Manhole Inspection Summary

Manhole # S17E__009MH

Insp Date: **10/8/07 12:16 PM**

Location Address: **300 WARWICK AVE**

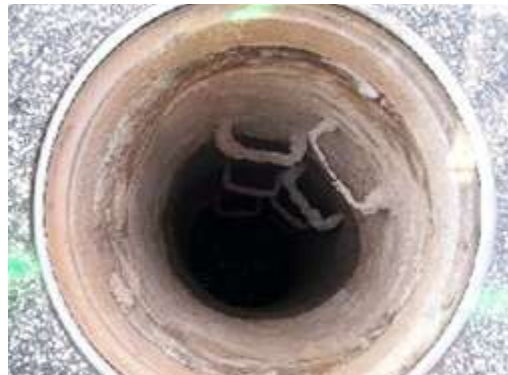
Defect 1

Count: **14** Missing: **0** ☒ **Corroded**

Steps corroded

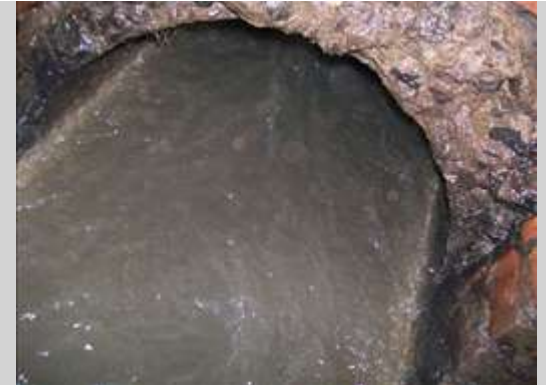
12 O'Clock Outflow

27 in. Circular Gravity Sewer
Pipe Out @ 12 O'Clock

Pipe Height: (in.) Direct
Pipe Material: **Clay** ☐ Pipe Lined
Invert Depth: **29.28** (ft.) Flow Characteristics: **Fast**
Deposits: ☒ None ☐ Mud ☐ Sludge ☐ Debris ☐ Grease
Silt Depth: (in.) Deposits Extent:
Infiltration: **None** Pipe Seal Cond: **Sound**

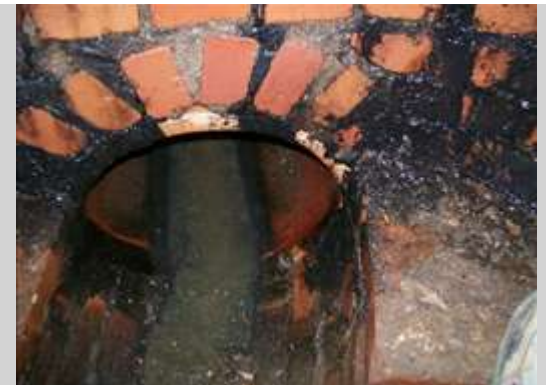
3 O'Clock Inflow

15 in. Circular Gravity Sewer
Pipe In @ 3 O'Clock

Pipe Height: (in.) Direct
Pipe Material: **Clay** ☐ Pipe Lined
Invert Depth: **27.85** (ft.) Flow Characteristics: **Slow**
Deposits: ☒ None ☐ Mud ☐ Sludge ☐ Debris ☐ Grease
Silt Depth: (in.) Deposits Extent:
Infiltration: **None** Pipe Seal Cond: **Sound**

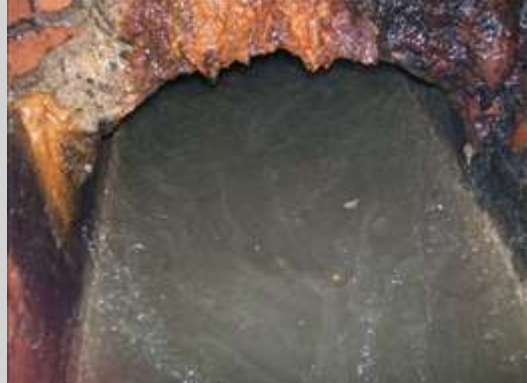
6 O'Clock Inflow

27 in. Circular Gravity Sewer

Pipe In @ 6 O'Clock

Invert Depth: **29.01** (ft.) Flow Characteristics: **Fast**

Infiltration: **None** Pipe Seal Cond: **Sound**
